# Crummock Water Weir Removal and River Cocker and Restoration Bed Level Information

# Outflow Design

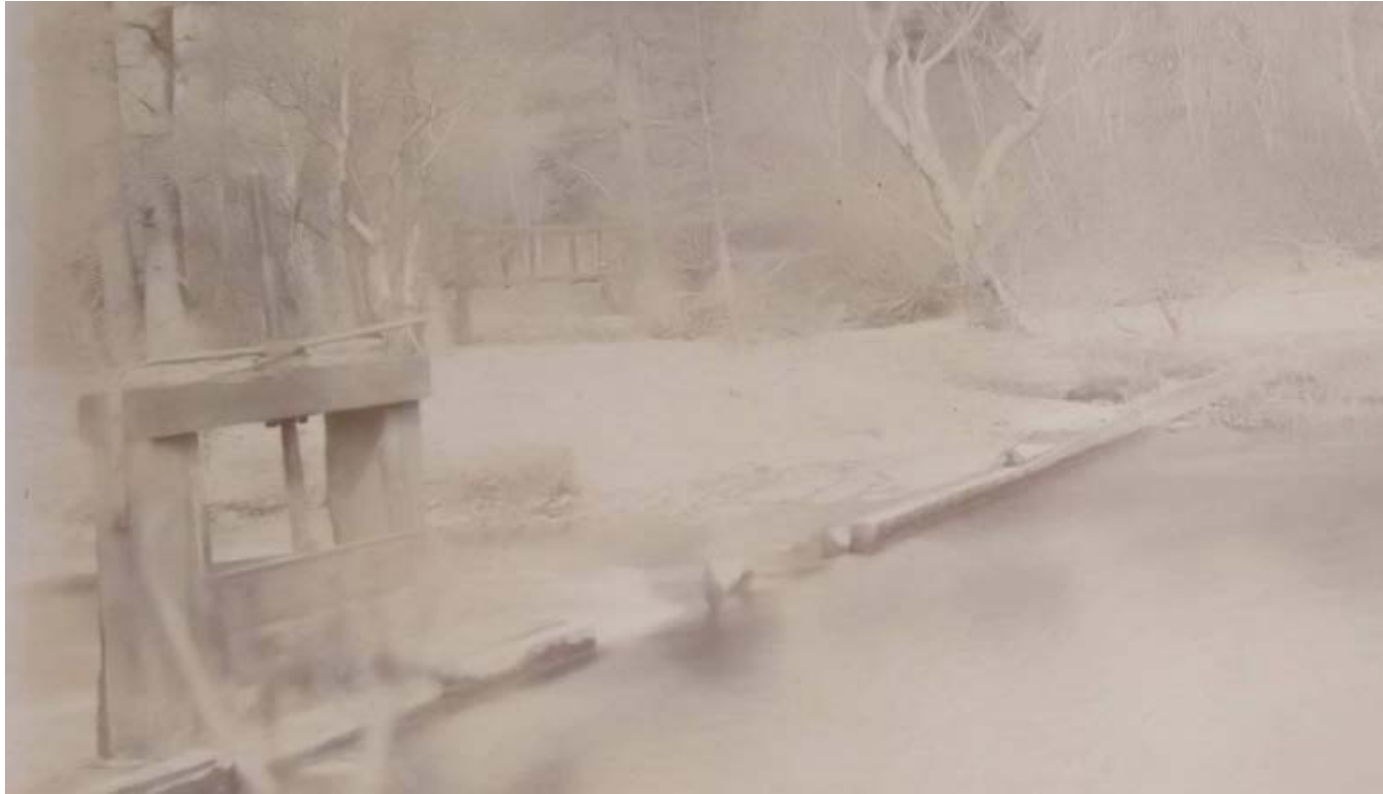
The photograph (left) demonstrates that the crest of the weir is higher than the bed level of the River Cocker downstream. The sketch (right) depicts the fish pass on the right side of the weir and the sluice gate on the left side of the weir

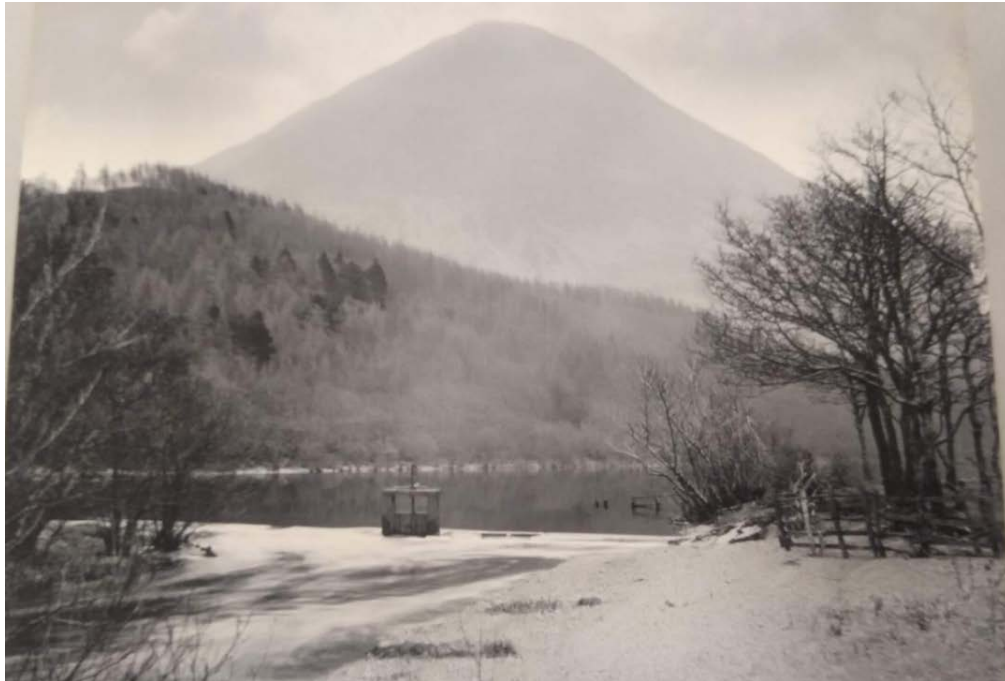
At high water levels the timber weir became submerged. This also happens with the existing weir at high flows.

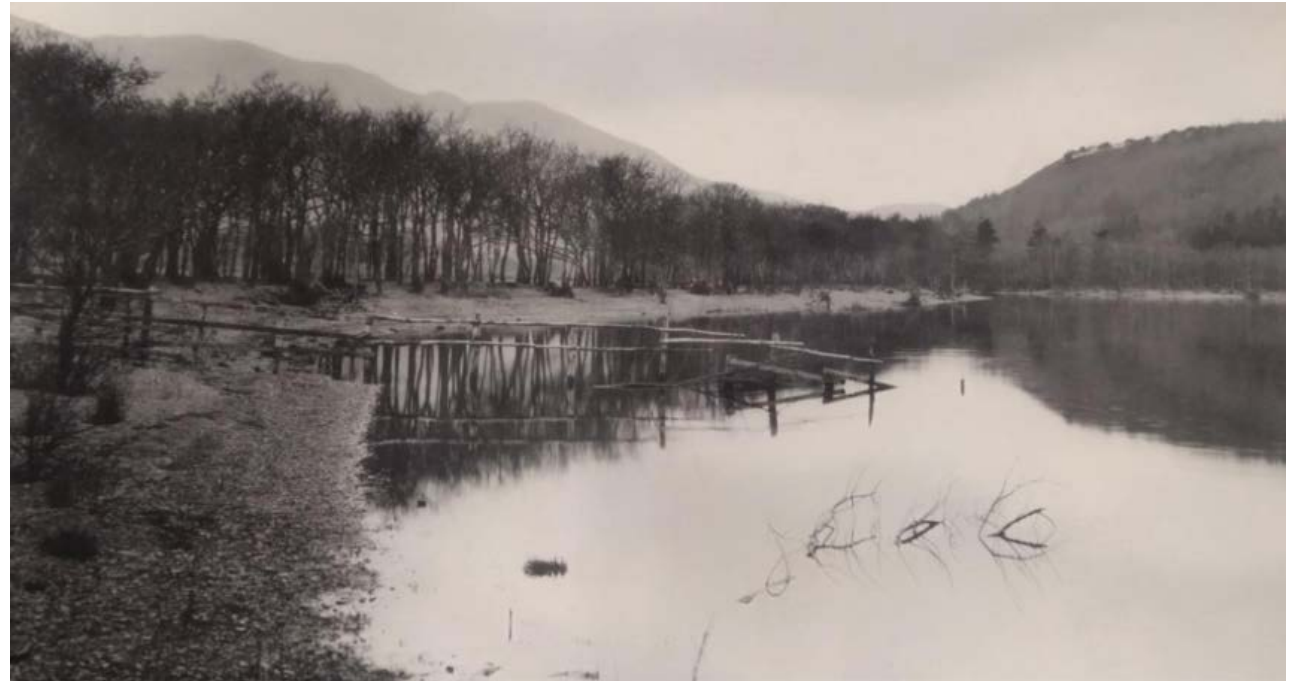
The shoreline of Crummock Water is gravelly; the lake level will fluctuate with rainfall / tributary inflow as it did in the 19<sup>th</sup> century and as it does currently. Removal of the existing weir and re-profiling of the River Cocker channels will reduce the outflow potential, and the range of lake levels will fluctuate more widely. Hydraulic modelling suggests the peak water level will be up to 1.5 m higher for a Q100 flood event (1% annual exceedance probability; 1:100 year flood event), compared to approximately 1 m now but the flood level is at a lower elevation compared with existing.
